FY2019 Summary Report & FY2020 Coordinated Monitoring

**CANADIAN AND RED RIVER
BASINS ADVISORY COMMITTEE MEETING**

APRIL 9, 2019 – AMARILLO, TEXAS

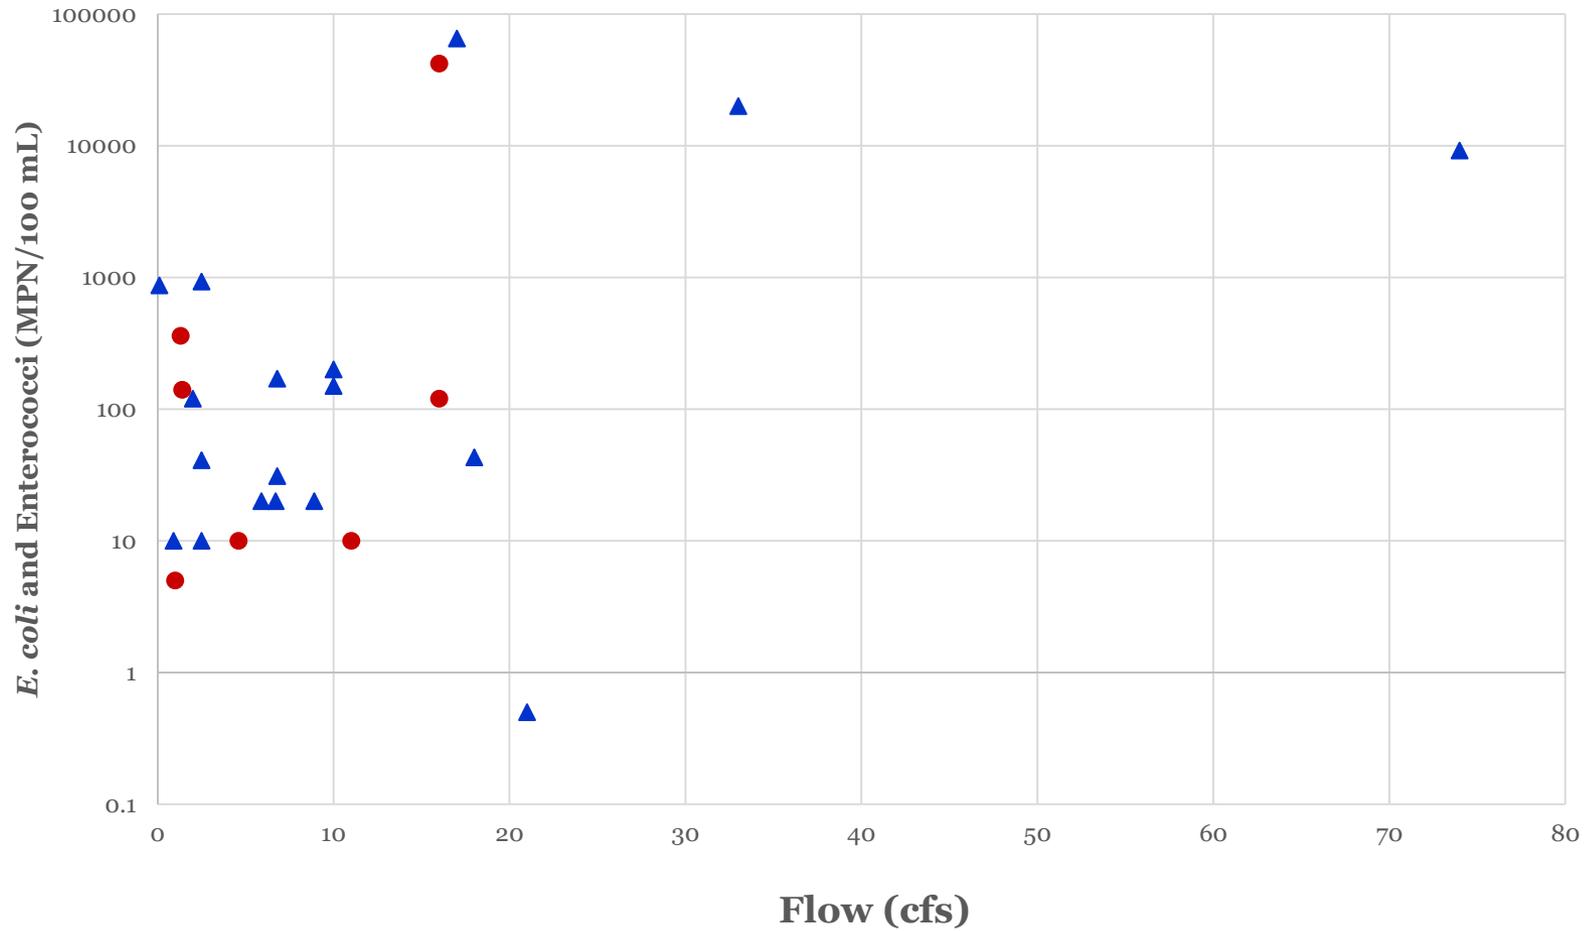
AU 0207_04 *E. coli* and *Enterococci* versus Flow

- Lower PDTF Red River (0207)
 - Bacteria impairment
 - Chlorophyll-*a* and Nitrate concern
- Buck Creek (0207A)
- Mackenzie Reservoir (0228)
- Upper PDTF Red River (0229)
- Lake Tanglewood (0229A)

▲ *E. coli* (MPN/100 mL)

● *Enterococci* (MPN/100 mL)

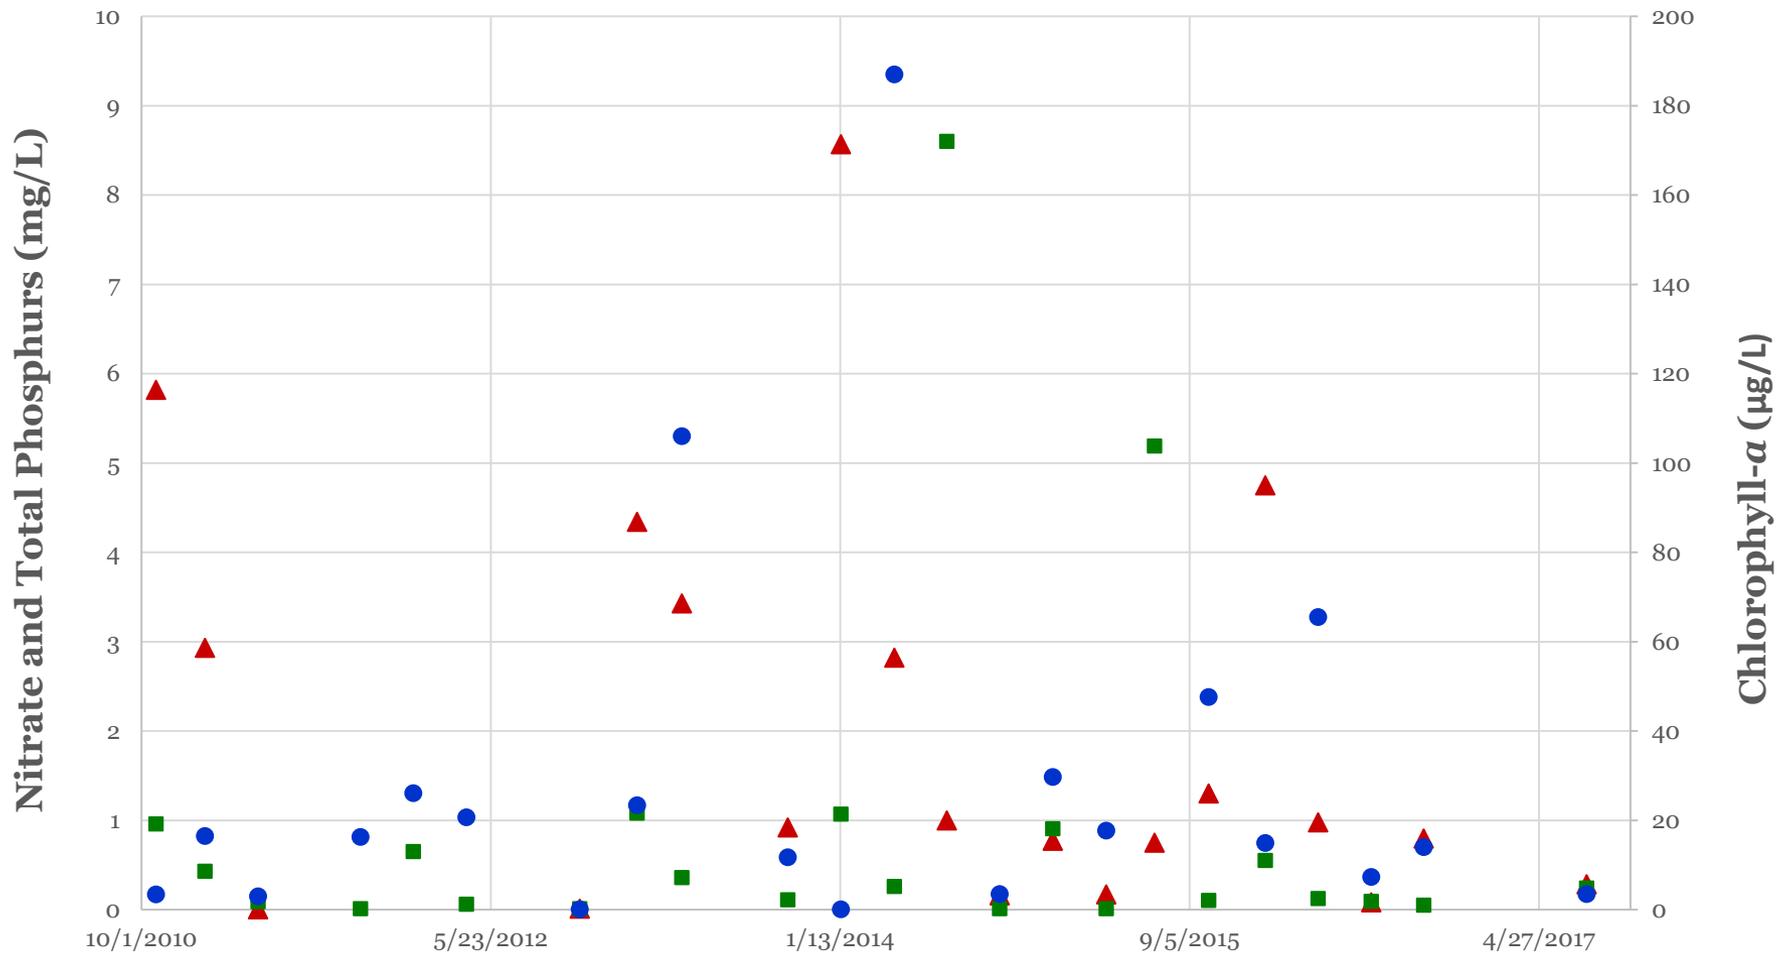
AU 0207_04

Nitrate, Total Phosphorus, Chlorophyll-*a*

▲ Nitrate ■ Total Phosphorus ● Chlorophyll

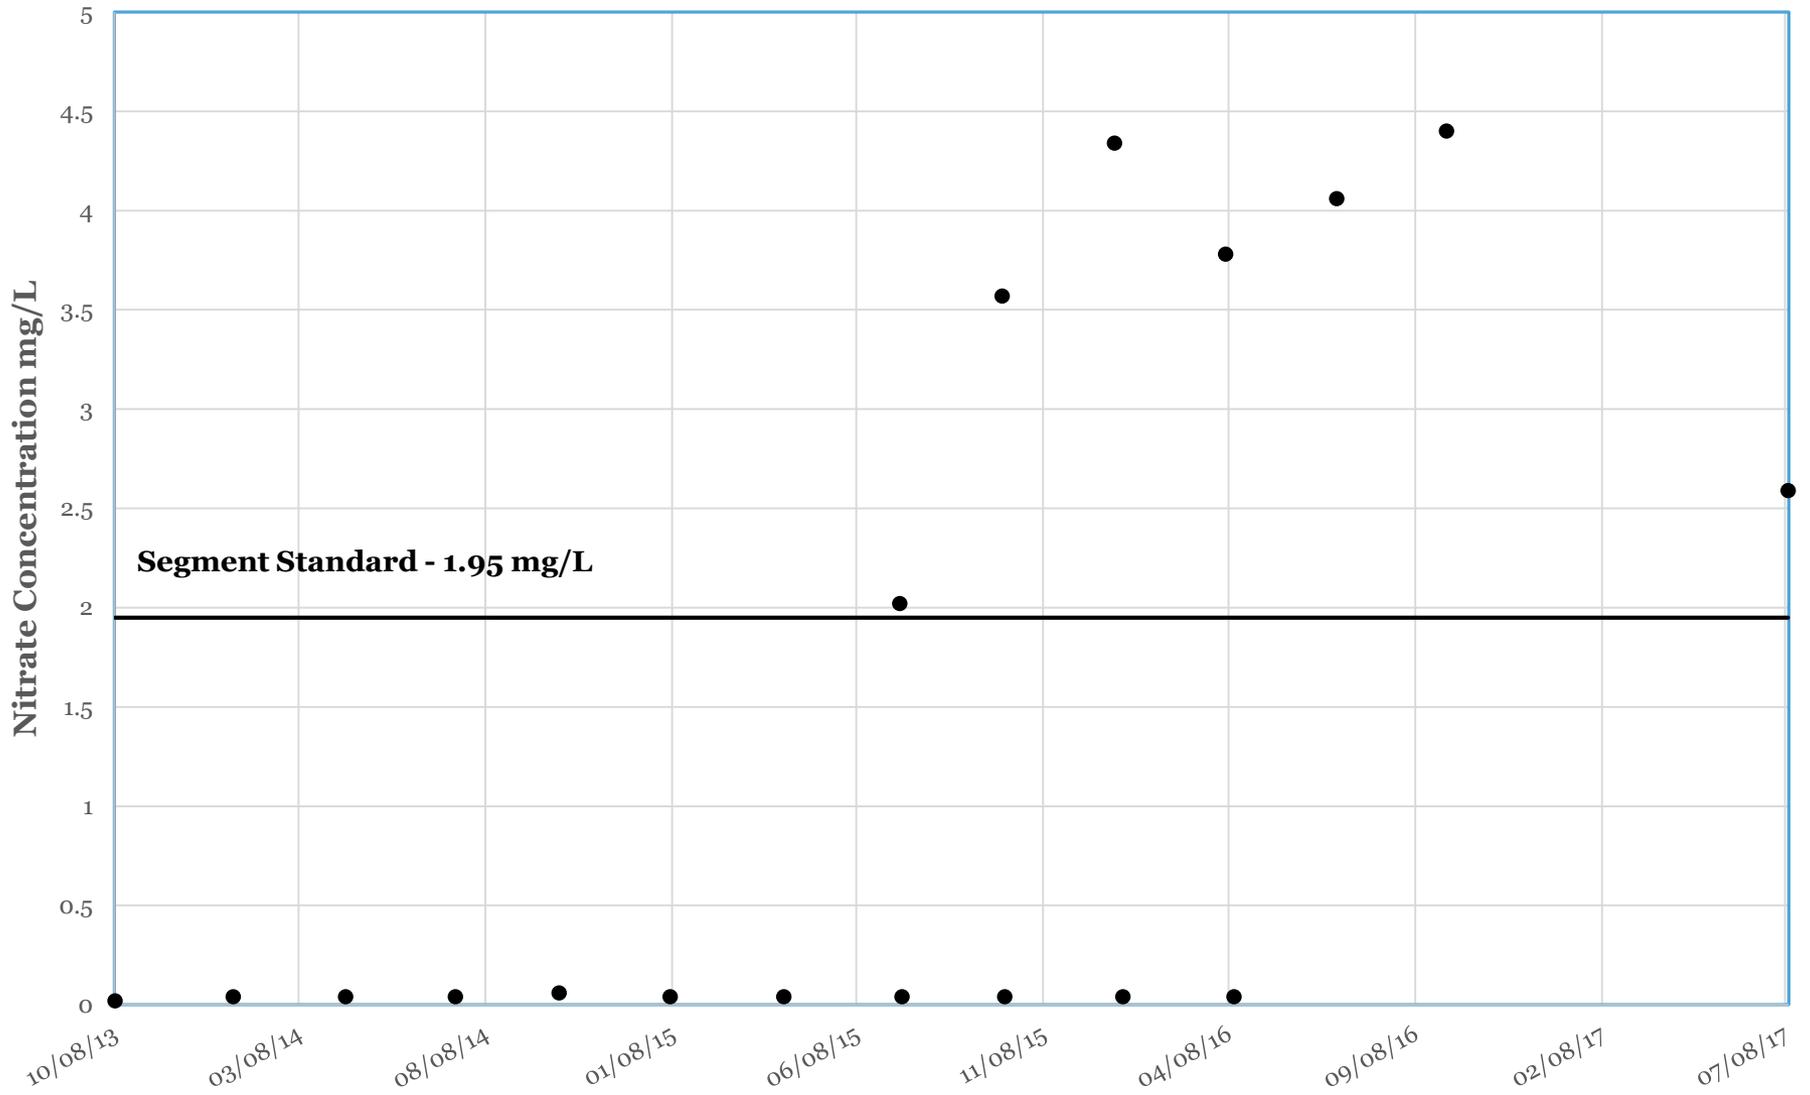
**Buck Creek
Segment 0207A_01
Nitrate**

- Lower PDTF Red River (0207)
- Buck Creek (0207A)
 - No impairments
 - Nitrate concern
- Mackenzie Reservoir (0228)
- Upper PDTF Red River (0229)
- Lake Tanglewood (0229A)

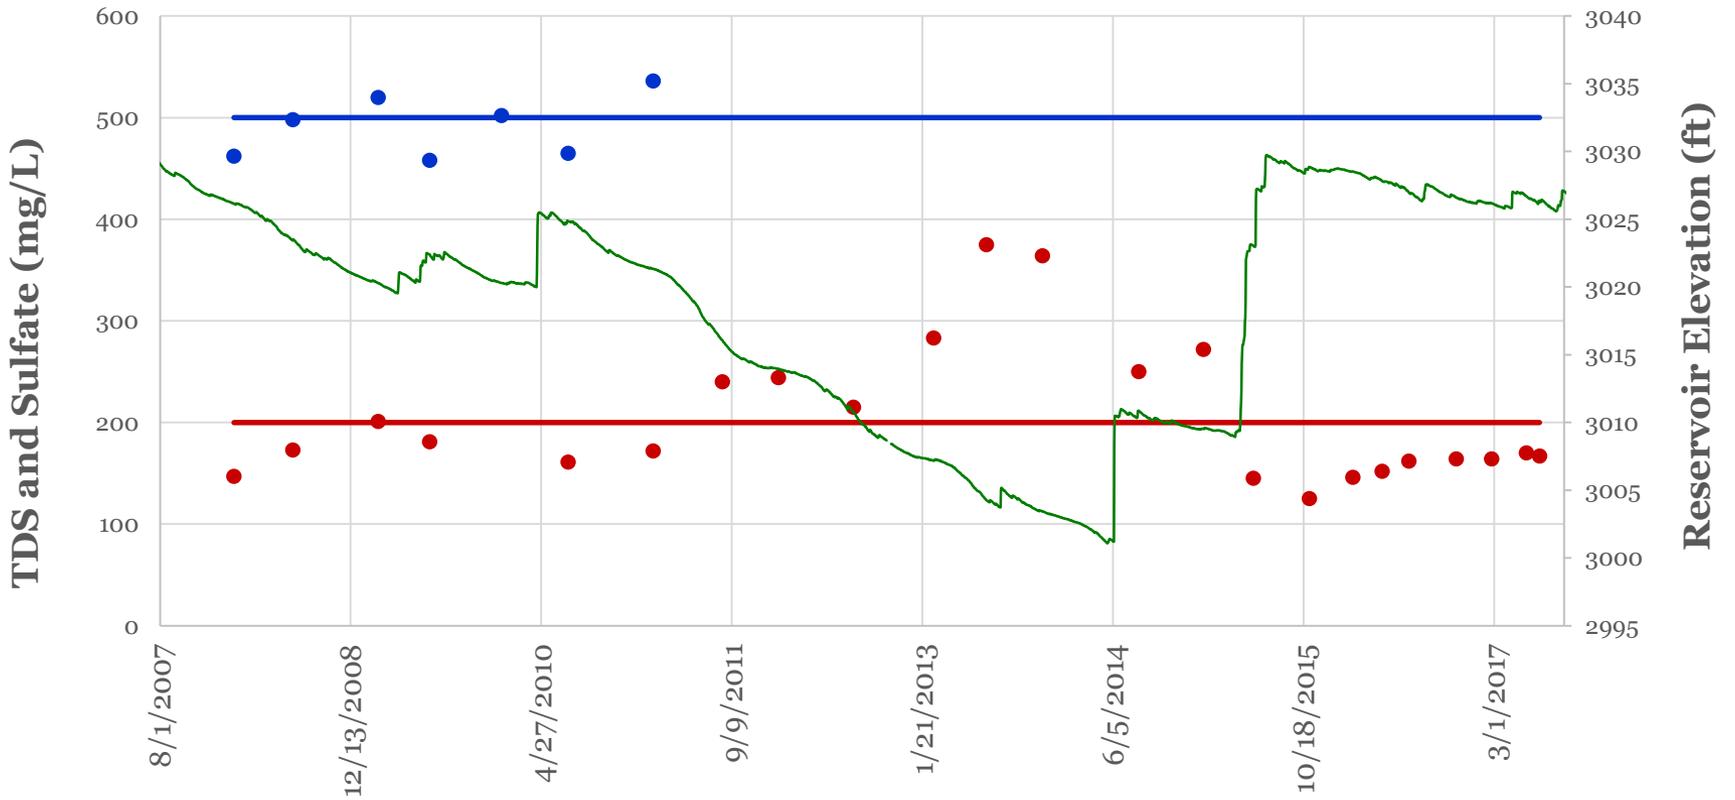
AU 0228_01 TDS, Sulfate, and Reservoir Elevation

- Lower PDTF Red River (0207)
- Buck Creek (0207A)
- Mackenzie Reservoir (0228)
 - TDS and **Sulfate** impairment
 - No concerns
- Upper PDTF Red River (0229)
- Lake Tanglewood (0229A)

- Total Dissolved Solids (mg/L)
- Sulfate (mg/L)
- Total Dissolved Solids Standard
- Sulfate Standard
- Reservoir Elevation (ft)

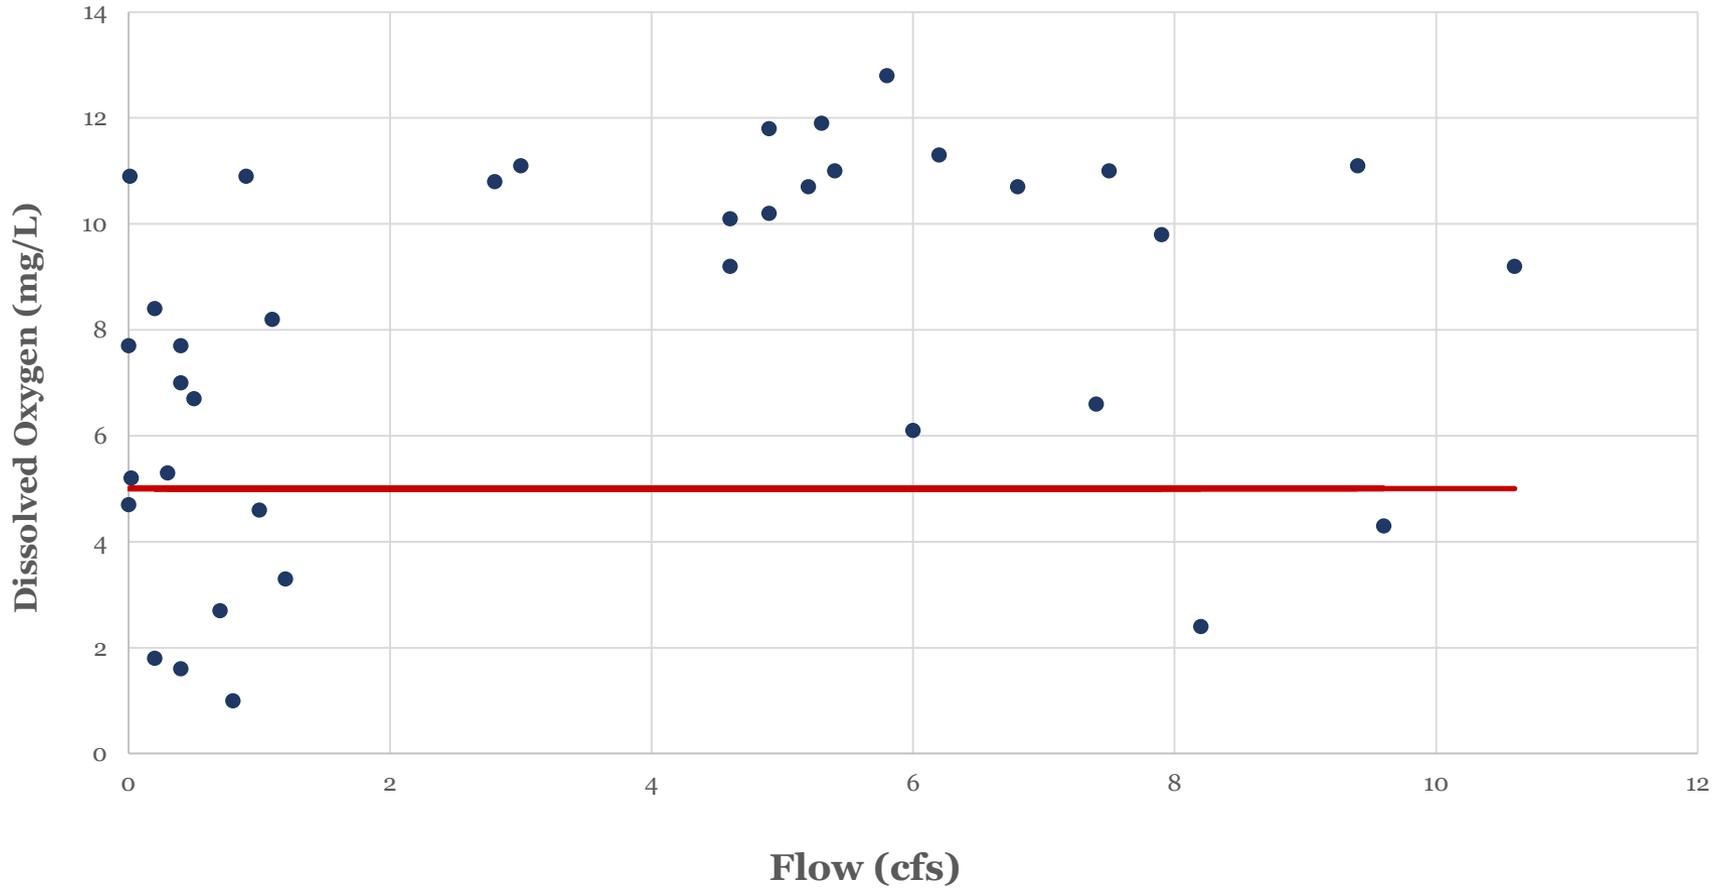
AU 0229_02 Dissolved Oxygen versus Flow

- Lower PDTF Red River (0207)
- Buck Creek (0207A)
- Mackenzie Reservoir (0228)
- Upper PDTF Red River (0229)
 - No impairments
 - Chlorophyll-*a*, nitrate, bacteria, depressed DO, and total phosphorus concerns
- Lake Tanglewood (0229A)

● Dissolved Oxygen (mg/L) — Dissolved Oxygen Screening Level

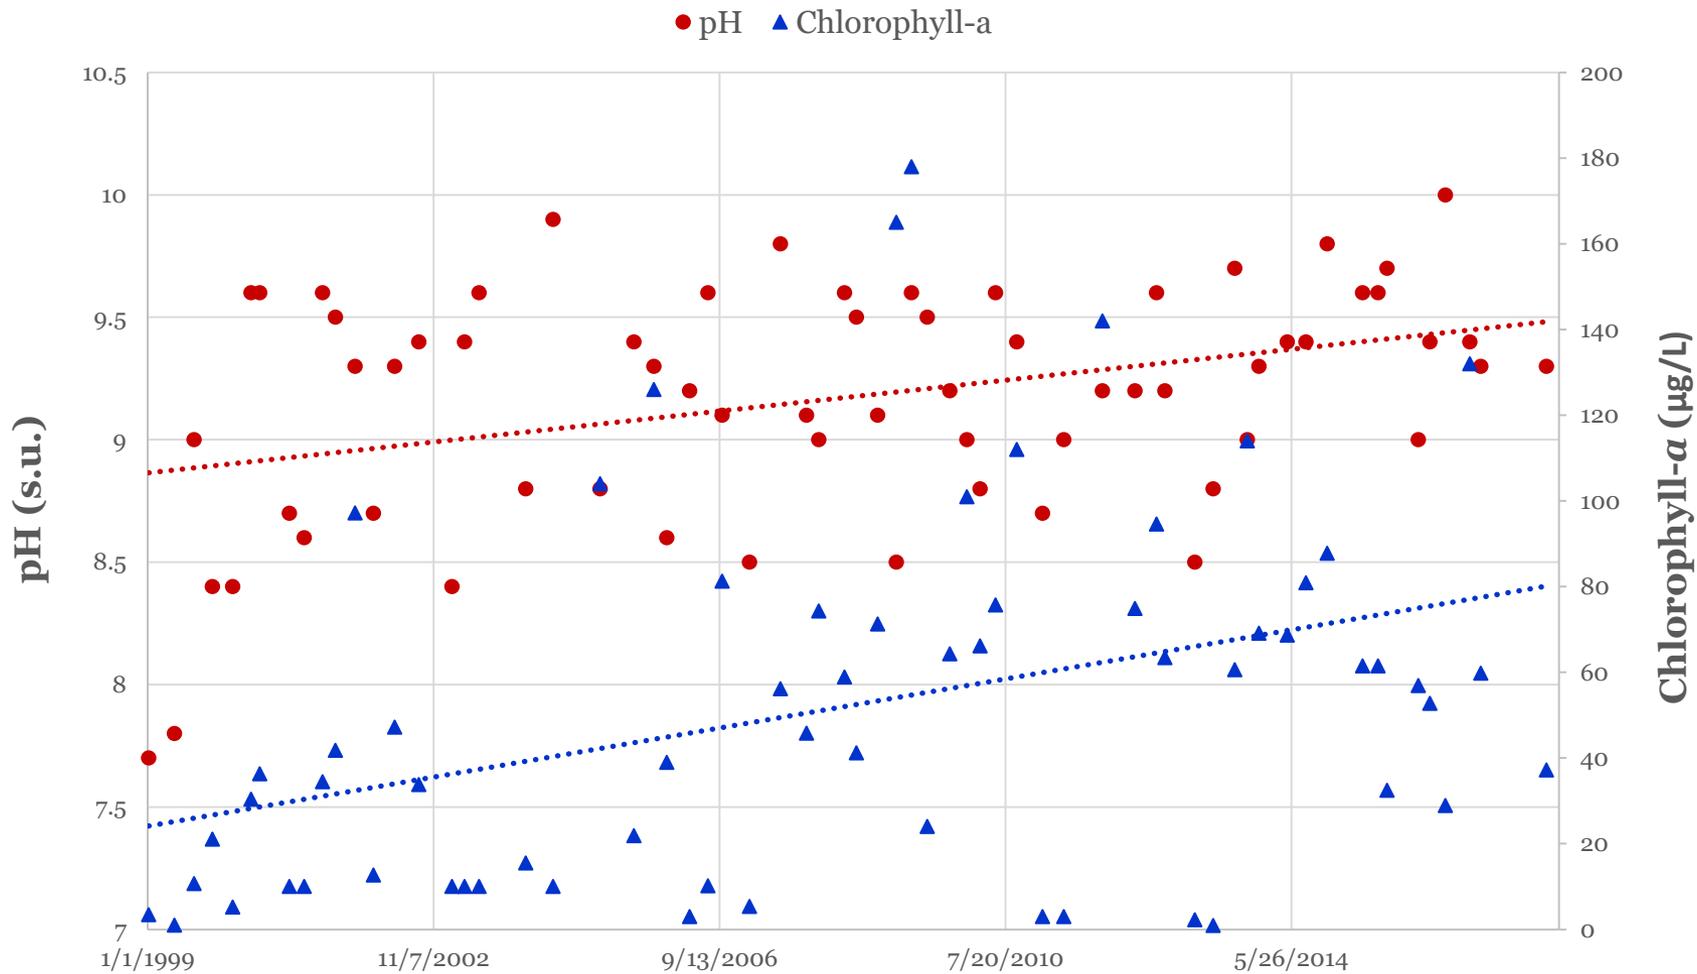
Segment 0229A pH and Chlorophyll-a

- Lower PDTF Red River (0207)
- Buck Creek (0207A)
- Mackenzie Reservoir (0228)
- Upper PDTF Red River (0229)
- Lake Tanglewood (0229A)
 - No impairments
 - Harmful Algal Blooms and Depressed Do concerns

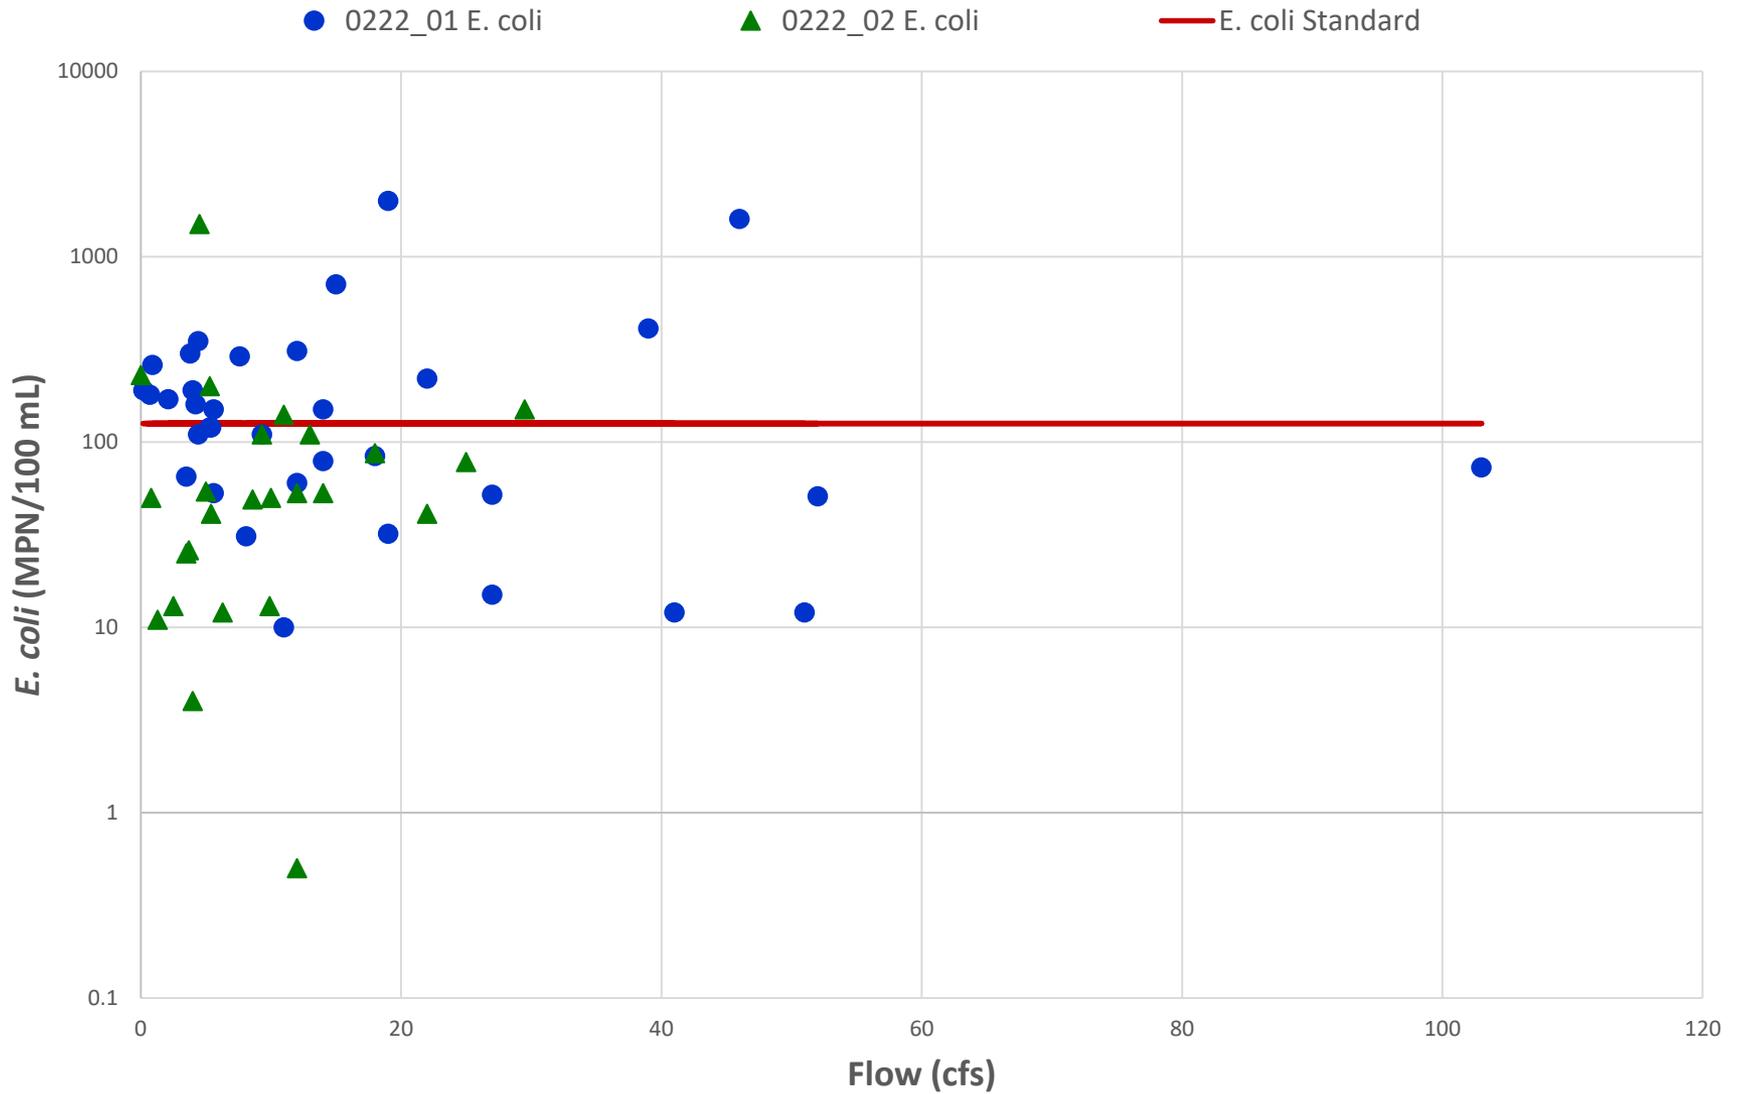
Segment 0222 *E. coli* versus Flow

- Salt Fork of the Red River (0222)
 - Bacteria impairment
 - Nitrate concern
- Lelia Lake Creek (0222A)
- Greenbelt Lake (0223)
- North Fork Red River (0224)
- McClellan Creek (0224A)
- Sweetwater Creek (0299A)
